Preliminary Report of the January 2011 Excavations at Highland House, Barbuda, Antigua/Barbuda

BARC Report 2011-2

May 2011, Contact – ghambrecht@gmail.com

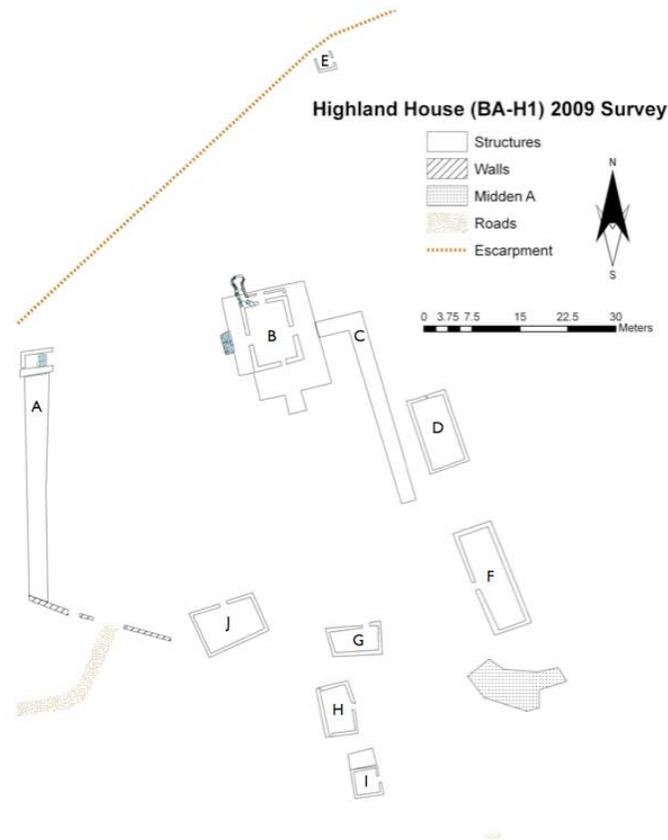
Figure 1 Map of the Highland House complex from the 2009 field report (Hambrecht and Look 2009)

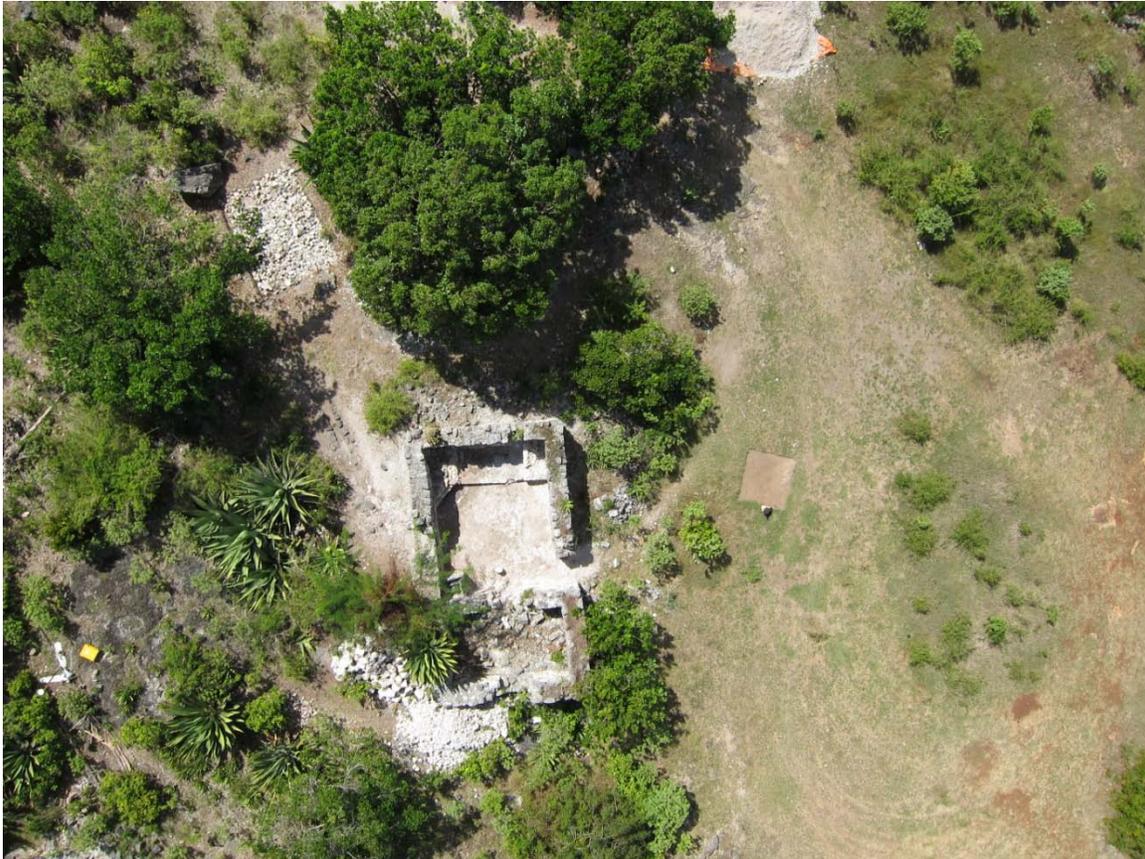
Figure 2 - Structure J is at the center of the photo. Note the drain (Structure K and the Group 2 midden excavations above and to the left.

Also relating to Structure J was a linear feature made of cut limestone of similar size and shape to Belgian blocks extending southwest of the building, likely emanating from an aperture in the southern wall. This, we believe was a drain fashioned to carry wastewater away from the building that ultimately terminated near the slope where the Group 2 sheet midden investigations were carried out.

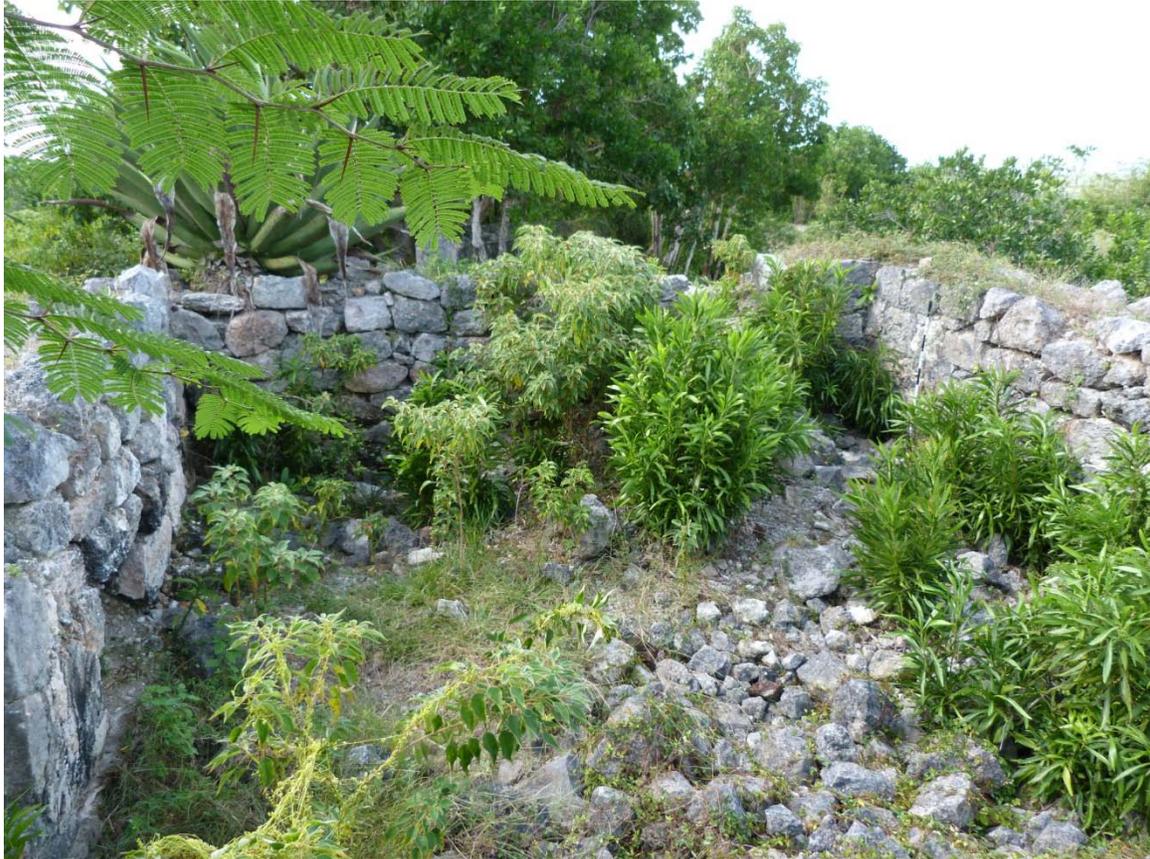
Figure 3 The interior of Structure J before excavation. The photograph was taken from the southeast corner of Side A. (photograph faces west).

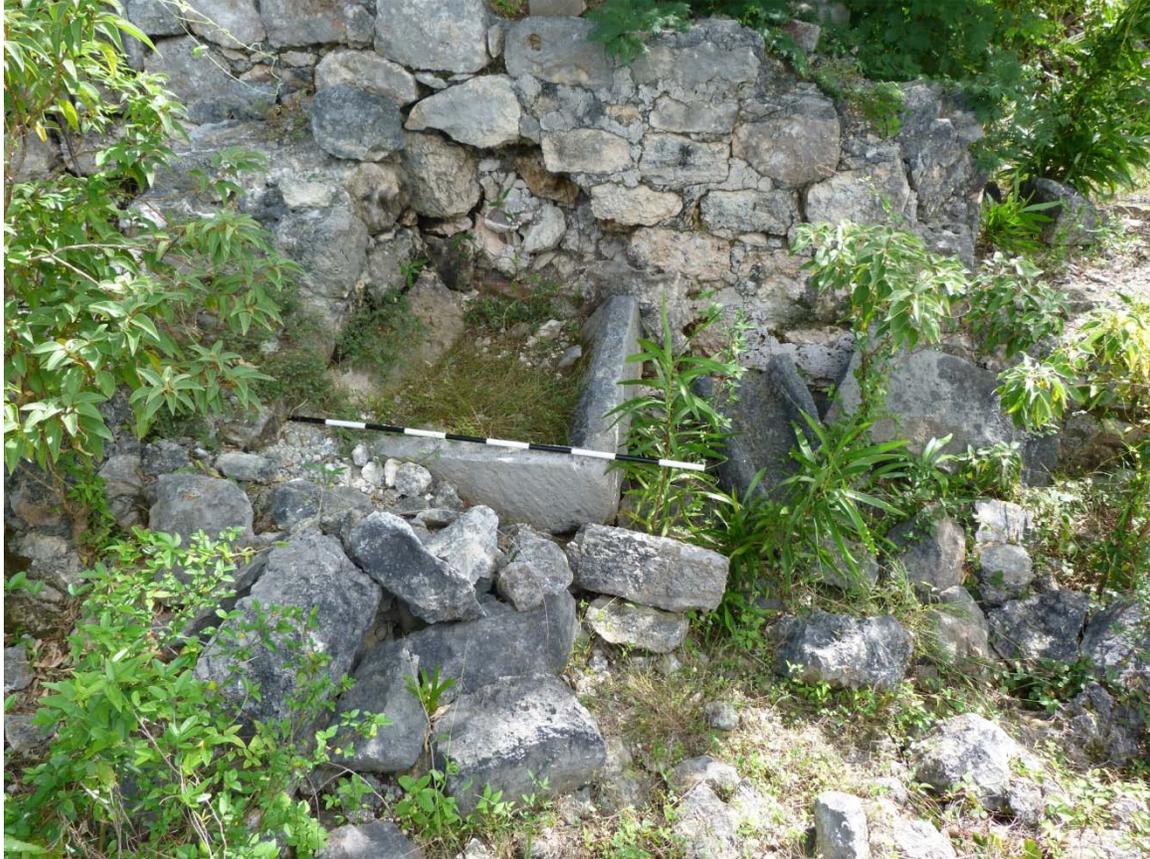
Figure 4 A carved stone basin was propped on limestone blocks in the south east corner of Structure J, side A.

Within side A, several significant features were already exposed. A carved stone basin or trough rests on rectangular limestone blocks at approximately waist height within the southeast corner. A broken fragment of a gutter, or perhaps a narrower portion of the same trough lay nearby on the southern wall as part of the surface debris. These features used for containing or controlling the flow of water re-enforce the notion that this buildings function was perhaps a washhouse or kitchen (Watters and Nicholson 1982, Hambrecht and Look 2009).

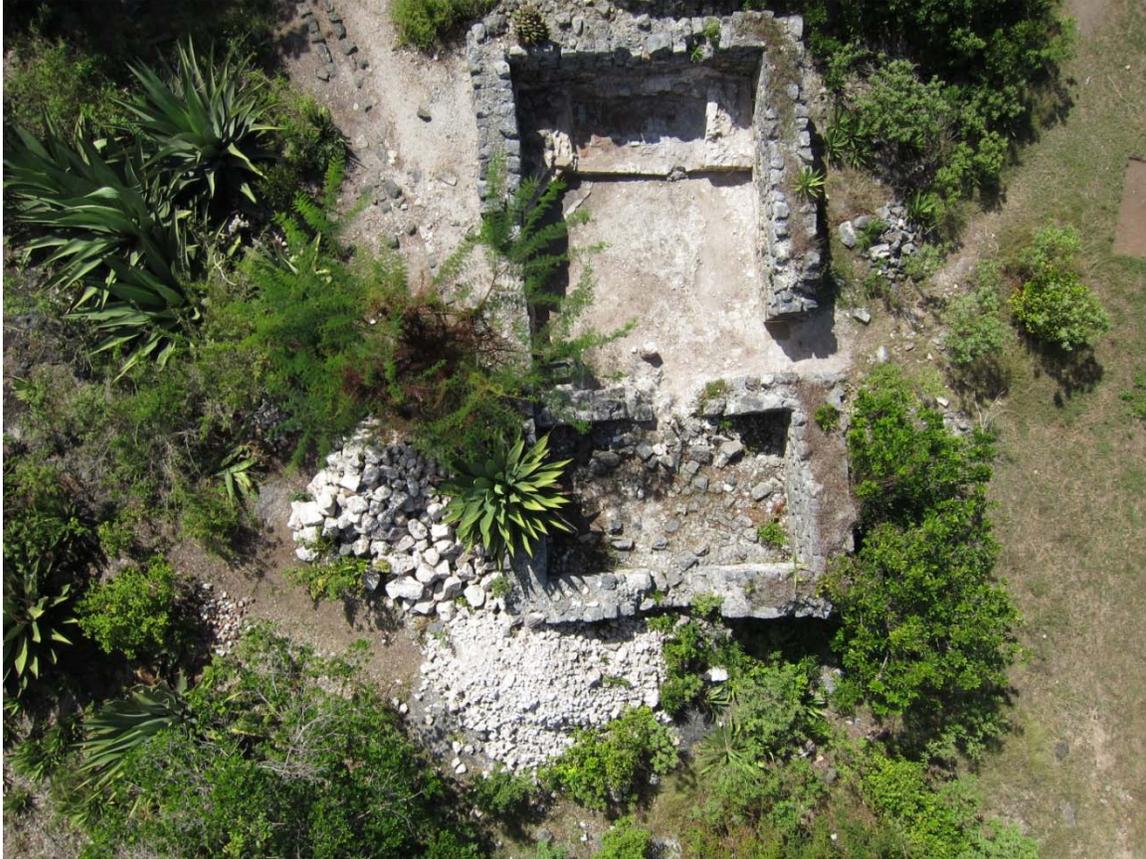
Figure 5 Overhead of Structure J after excavation. Note the drain (Structure K) at the top left of the picture.

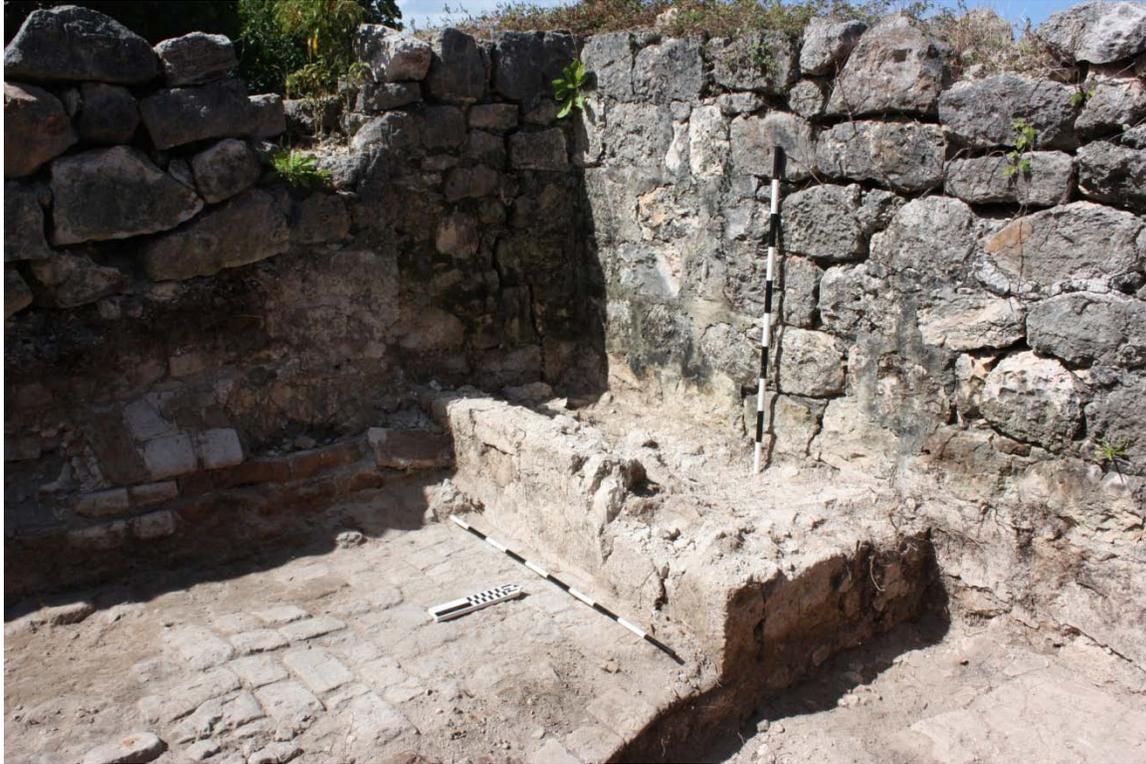
Figure 6 Rectangular stone feature in the NW corner of Structure J, adjacent to hearth now visible as the low brick platform to the left.

In the northwestern corner of Structure J was a rectangular arrangement of mortared limestone, but what remained only suggested a platform. It was obvious that mortared stone as missing from the top and its function could not be discerned with any certainty. No burnt remains were visible near this northern feature, and it's possible that the rectangular base of stones merely supported a large chimney that likely capped the central hearth.

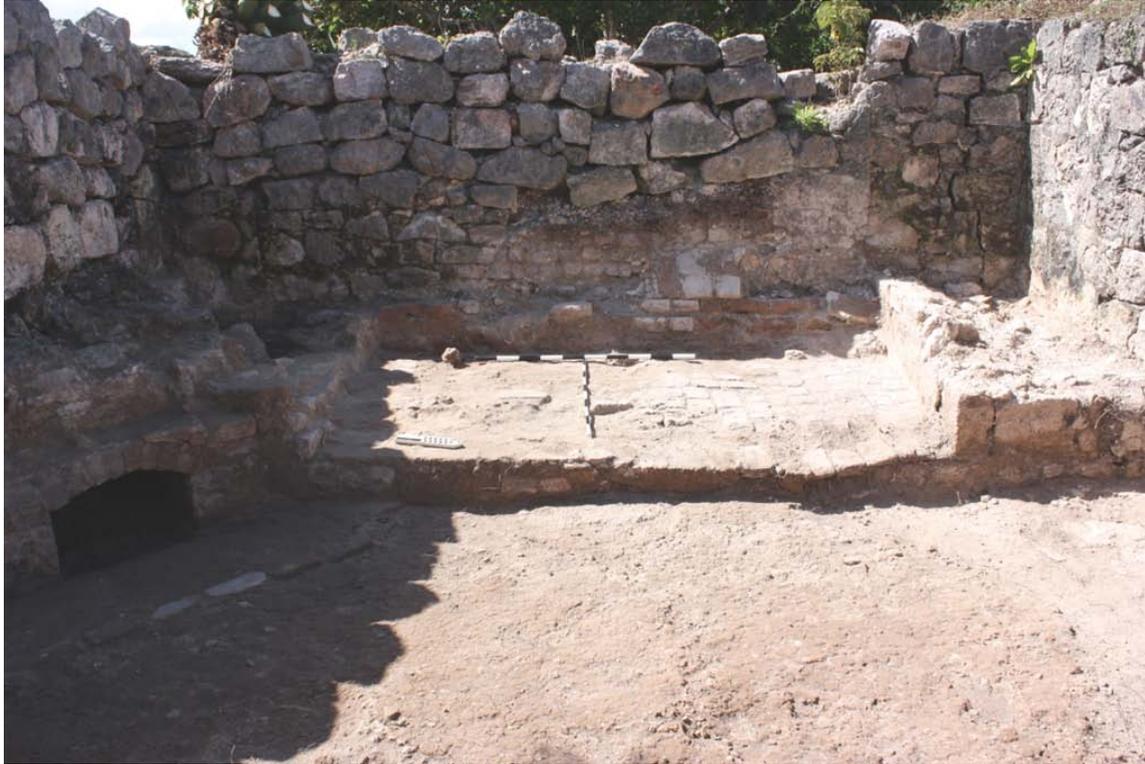
Figure 7 Western wall of Structure J with extensive stone features including a low arched hearth and a central platform which was likely the floor of a large open stove with a chimney.

Along the western wall were three discreet features, with at least two being associated with evidence for burning. The southernmost is a low brick hearth reaching from floor level to knee level, atop were the remains of a stone structure, which could have been a chimney, or a related chamber like a bake-oven. To the north of that was a brick and limestone platform, the entirety of which most likely was beneath a large chimney. Plentiful brick fall was found amongst the rubble removed from structure J and it is reasonable that these bricks may have composed interior chimneys.

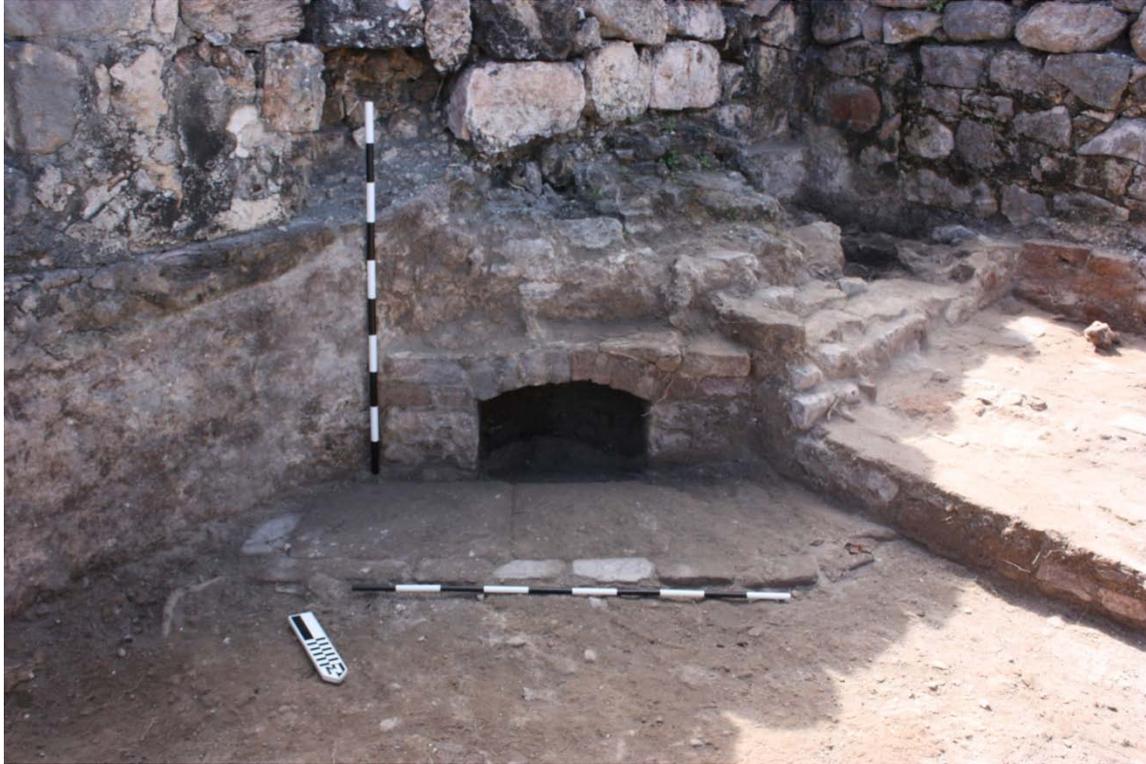
Figure 8 The hearth or oven in the southwest corner of the structure. The intact hearth is very low and there is significant intact masonry above it suggesting either a substantial chimney or possibly a specialized oven above.

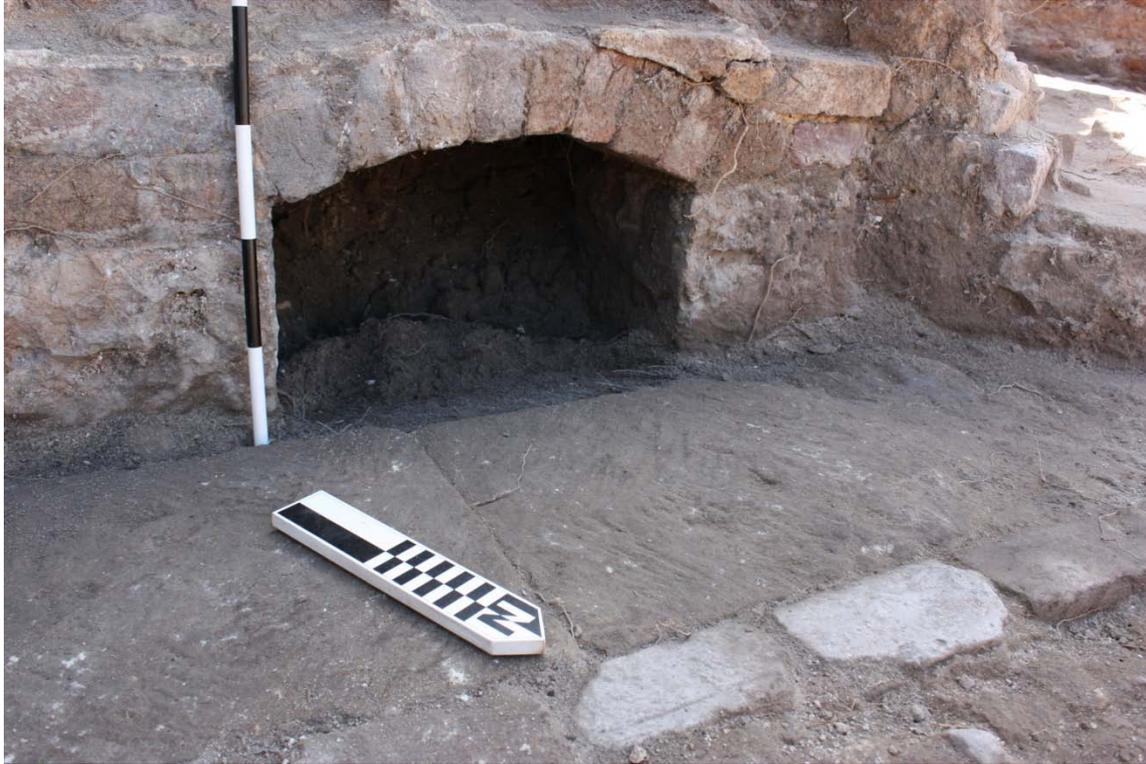
Figure 9 A closer view of the low arched hearth

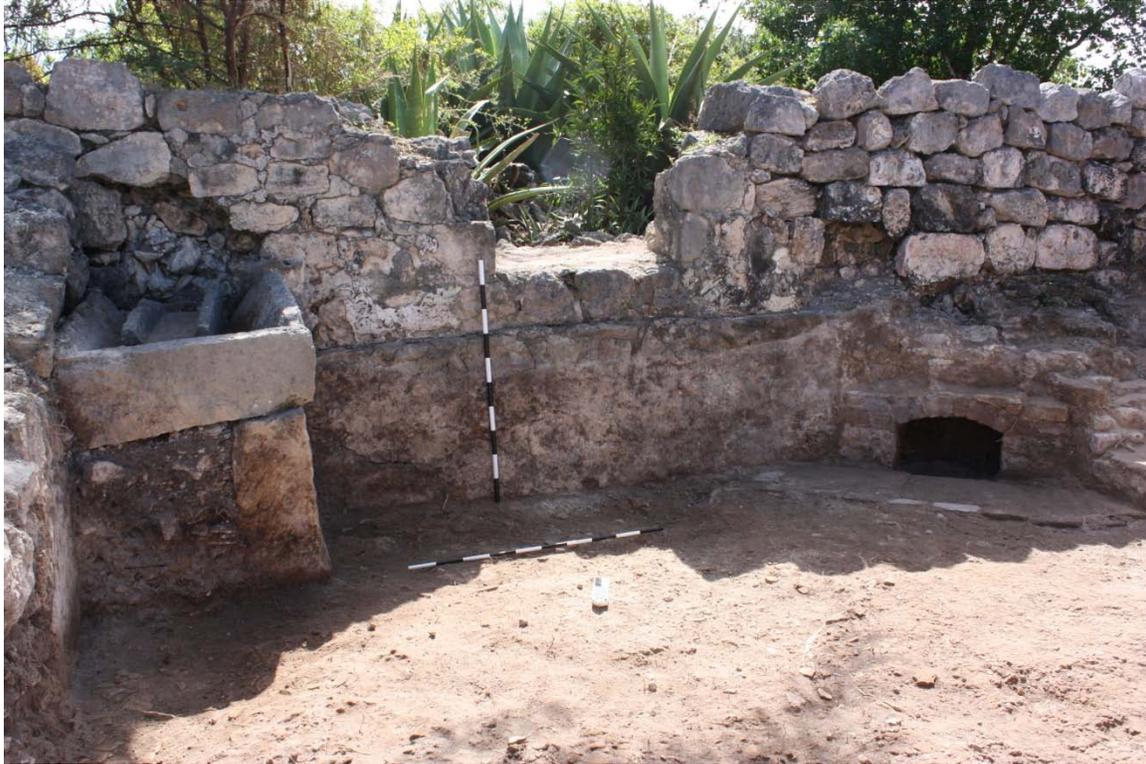
Figure 10 The interior southern wall of Structure J. Showing the relationship between the carved basin and the hearth. It is possible the carved basin once sat in the aperture in the back of the building, as this is where structure K, the drain feature originates

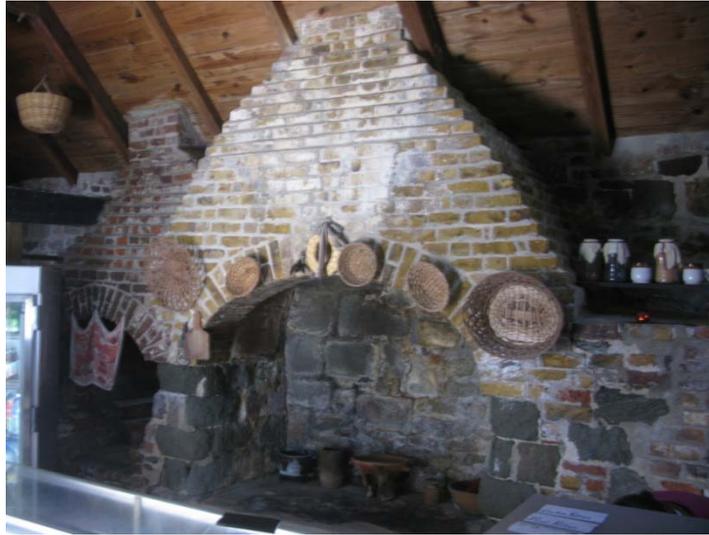
Figure 11. 18th Century oven complex in a cookhouse in Nelson's dockyard, Antigua. The arrangement of the hearths may resemble that of the original arrangement at Highland House in that there appear to be three sections with the largest section in the middle.

It's significant to note that the oven complex shown in the photographs above, taken at Nelson's dockyard, Antigua, which was meant to serve a community, could be similar in size to that at Highland House. This might suggest that if this structure was a kitchen, then it at times was producing food for a large group of people, or even for provisioning large groups of people elsewhere.

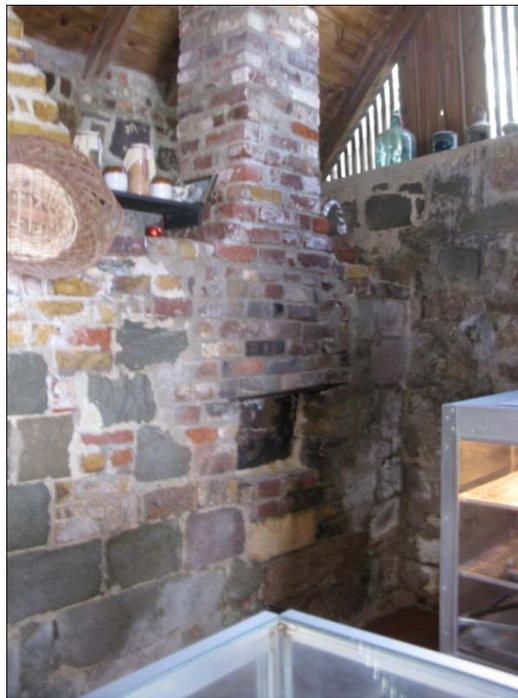
Figure 12. 18th century oven complex in a cookhouse in Nelson's Dockyard, Antigua. Depicts oven section furthest to the right in a series of three stove/ovens.

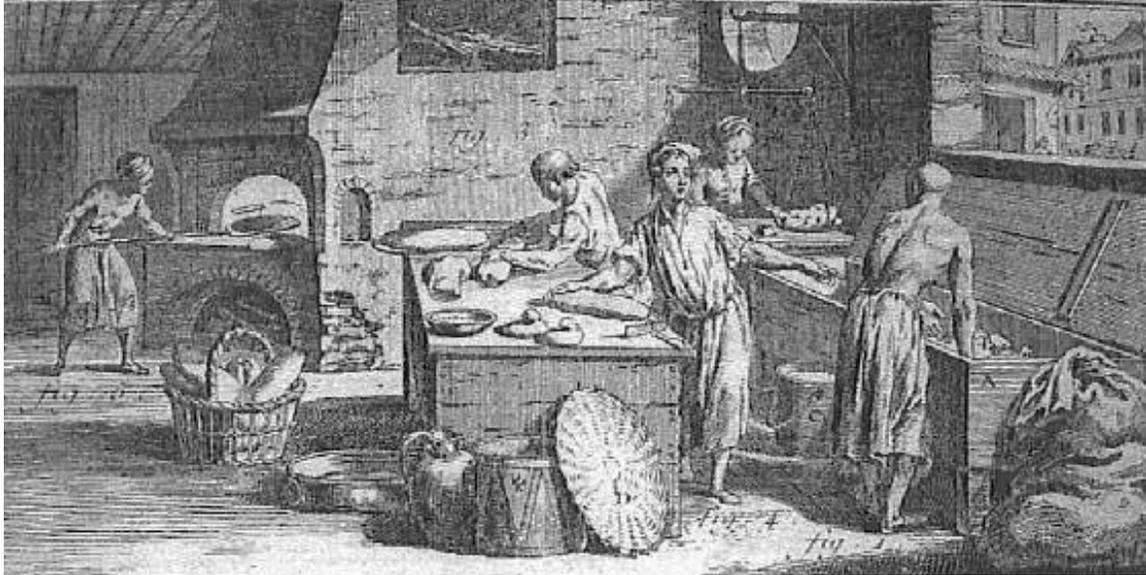
Figure 13. A 1760 engraving (Diderot) showing a bake oven with an arched brick hearth at its base. Depictions like the one above may suggest that the very low arched hearth in structure J could have been part of a larger and more complex structure.

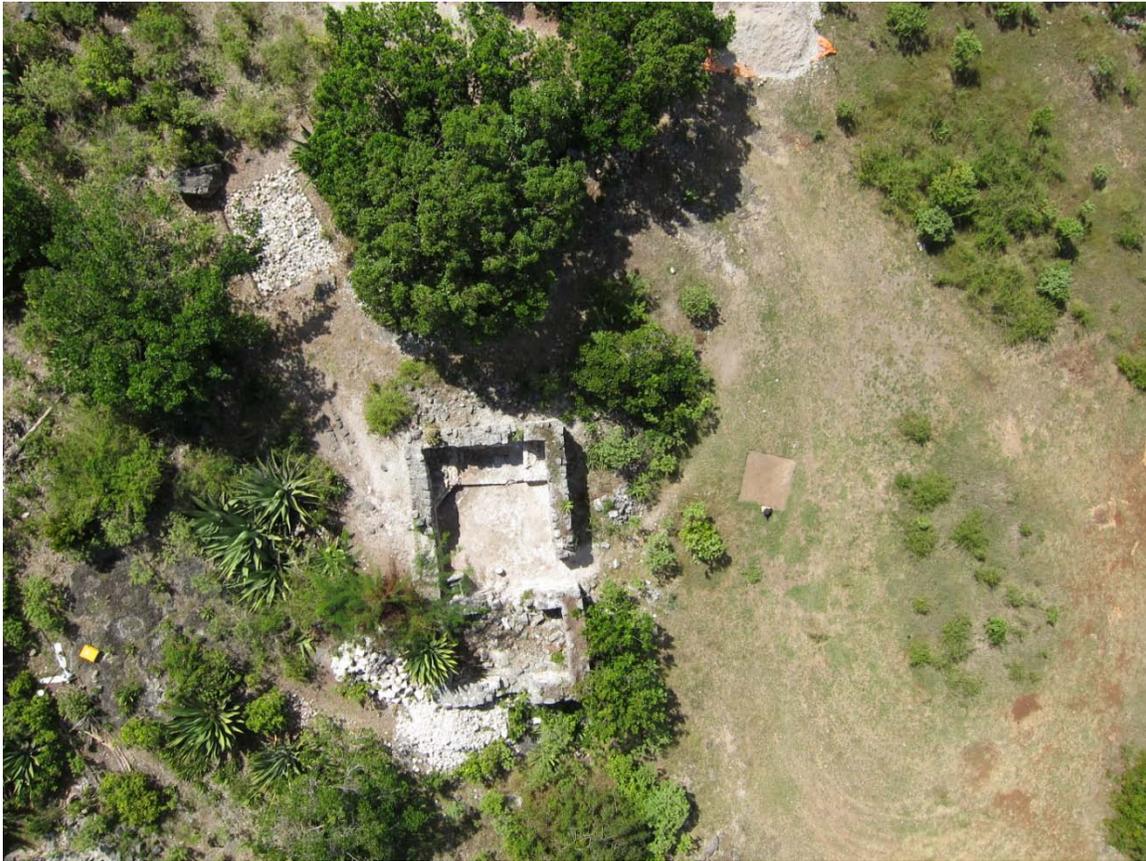
Figure 14 – Overhead of Structure’s J, K and the Group 2 excavation area. Group 2 is above and left of Structure J. This picture was taken after Group 2 had been filled with rubble to protect it for further excavation. Note that both Structure K and Group 2 are down slope from Structure J.

Group 2, a 3X5 meter trench, was opened up due to its location down slope from Structure K. We presumed that any waste that was poured into Structure K would travel down the drain and be deposited on the slope below. Surface finds of

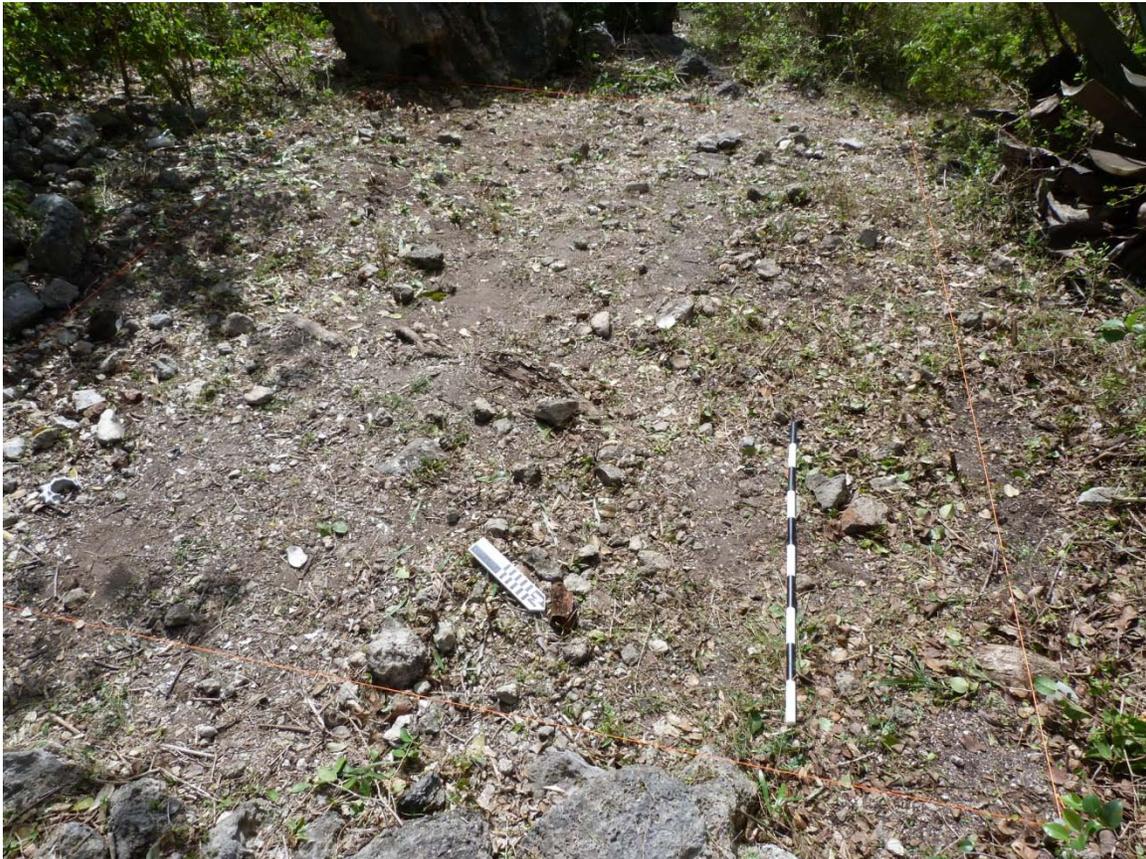
Figure 15 - The surface of Group 2 before excavation.

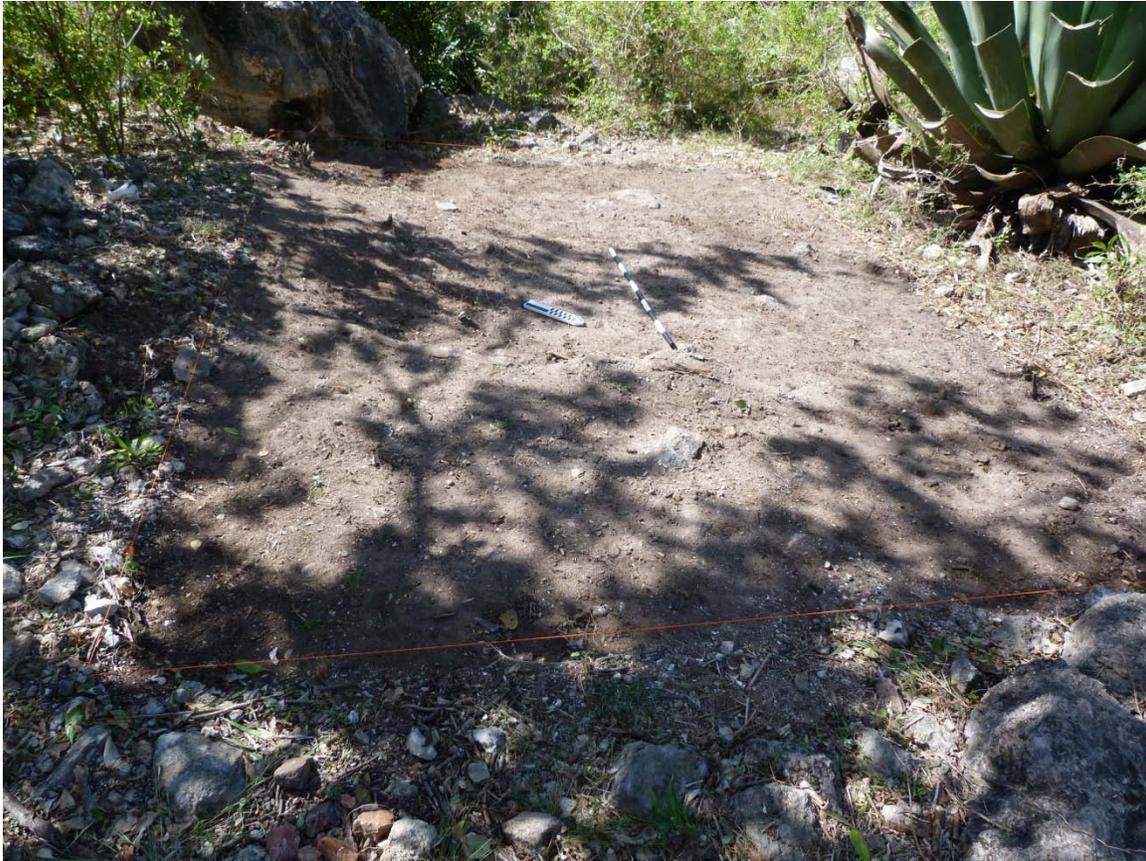
Figure 16 - The surface of context [006] Group 2.

Group 2 also contained a large amount of faunal material though this was dominated by *Cittarium pica* fragments. Context [006] contained the greatest amount of faunal material, again overwhelmingly dominated by shell and that by *Cittarium pica*. Mammal bone was present, though not in large numbers, and these were spread throughout all contexts.

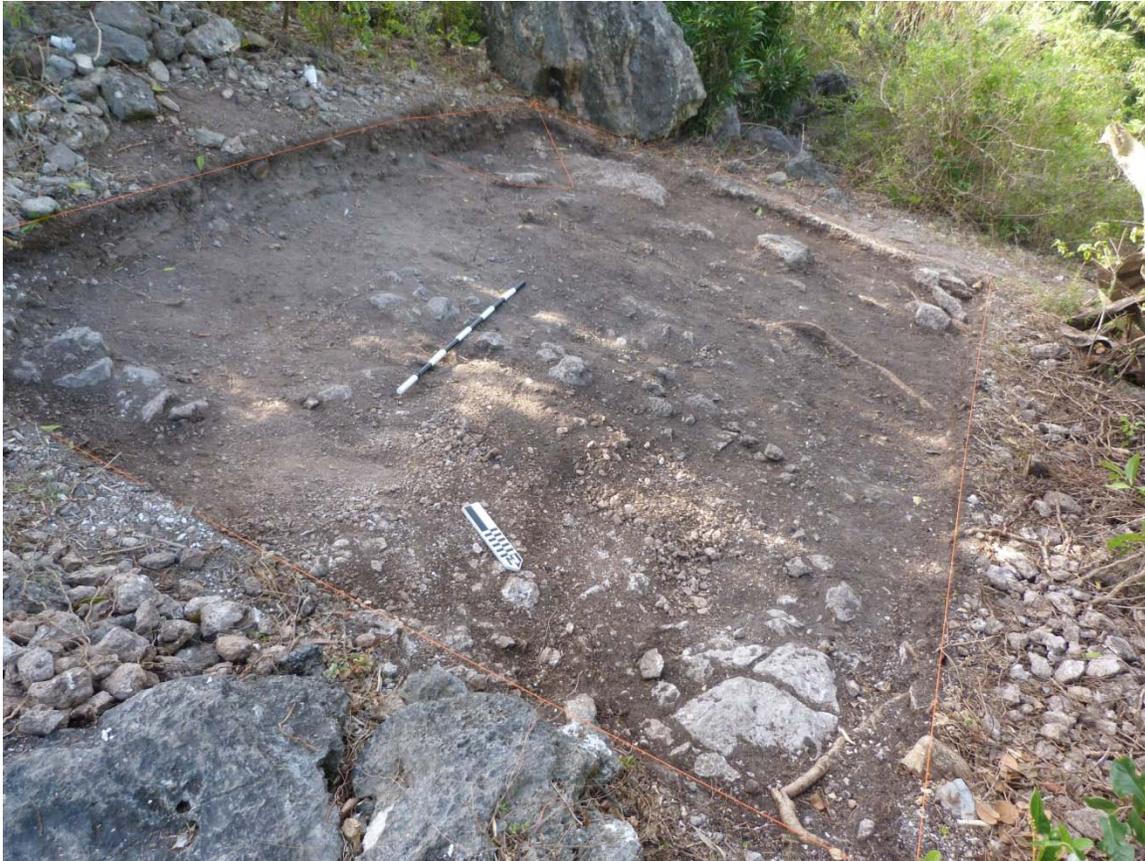
Figure 17 - Surface of context [021] Group 2.
